## MICROSTRUCTURE EVALUATION OF SERVICE AGED AND REJUVENATED NICKEL SUPER ALLOYS USING HOT ISOSTATIC PRESSING TREATMENT

**Abstract.** The design life of gas turbine blades is normally 48,000 equivalent operating hours (EOH) or 72,000 EOH based on the original equipment manufacturer (OEM) recommendation. Extending the service life of gas turbine blades is a huge advantage in the aspect of capital cost-saving in the power plant industries. The coarsening and shape transformation of  $\gamma'$  precipitates are one of the main life-limiting factors for gas turbine blades. Conventional heat treatment could not restore or recover  $\gamma'$ -phase precipitates to their original morphology. In this study, hot isostatic pressing (HIP) treatment was used to improve the material properties of the blades to nearly zero-hour operation and prolong the life of gas turbine blades. HIP rejuvenation applies high temperature and pressure to close the micropores, retransform the microphases (i.e.,  $\gamma'$ -phase precipitates), and heal the material properties. For this case study, three HIP parameters were applied on nickel-based superalloy (GTD-111). Microstructure characterization was carried

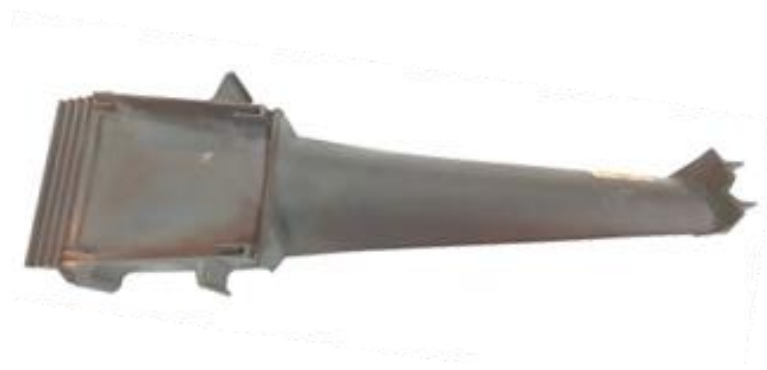
**Materials.** The material used was nickel-based superalloy (EQX GTD-111). The used or aged sample was obtained from a gas turbine blade with approximately 72,000 equivalent operating hours (EOH). Figure 2 shows the used blade of EQX GTD-111. The new material of EQX GTD-111 in rod form was purchased from Korea Lost Wax Ltd., South Korea. Figure 3 shows the samples of the new material with a diameter of 3 cm and a length of 25 cm. Table 1 presents the material composition of standard nickel-based superalloy (GTD-111).

**Figure 2. Used blade of GTD 111 EQX.**

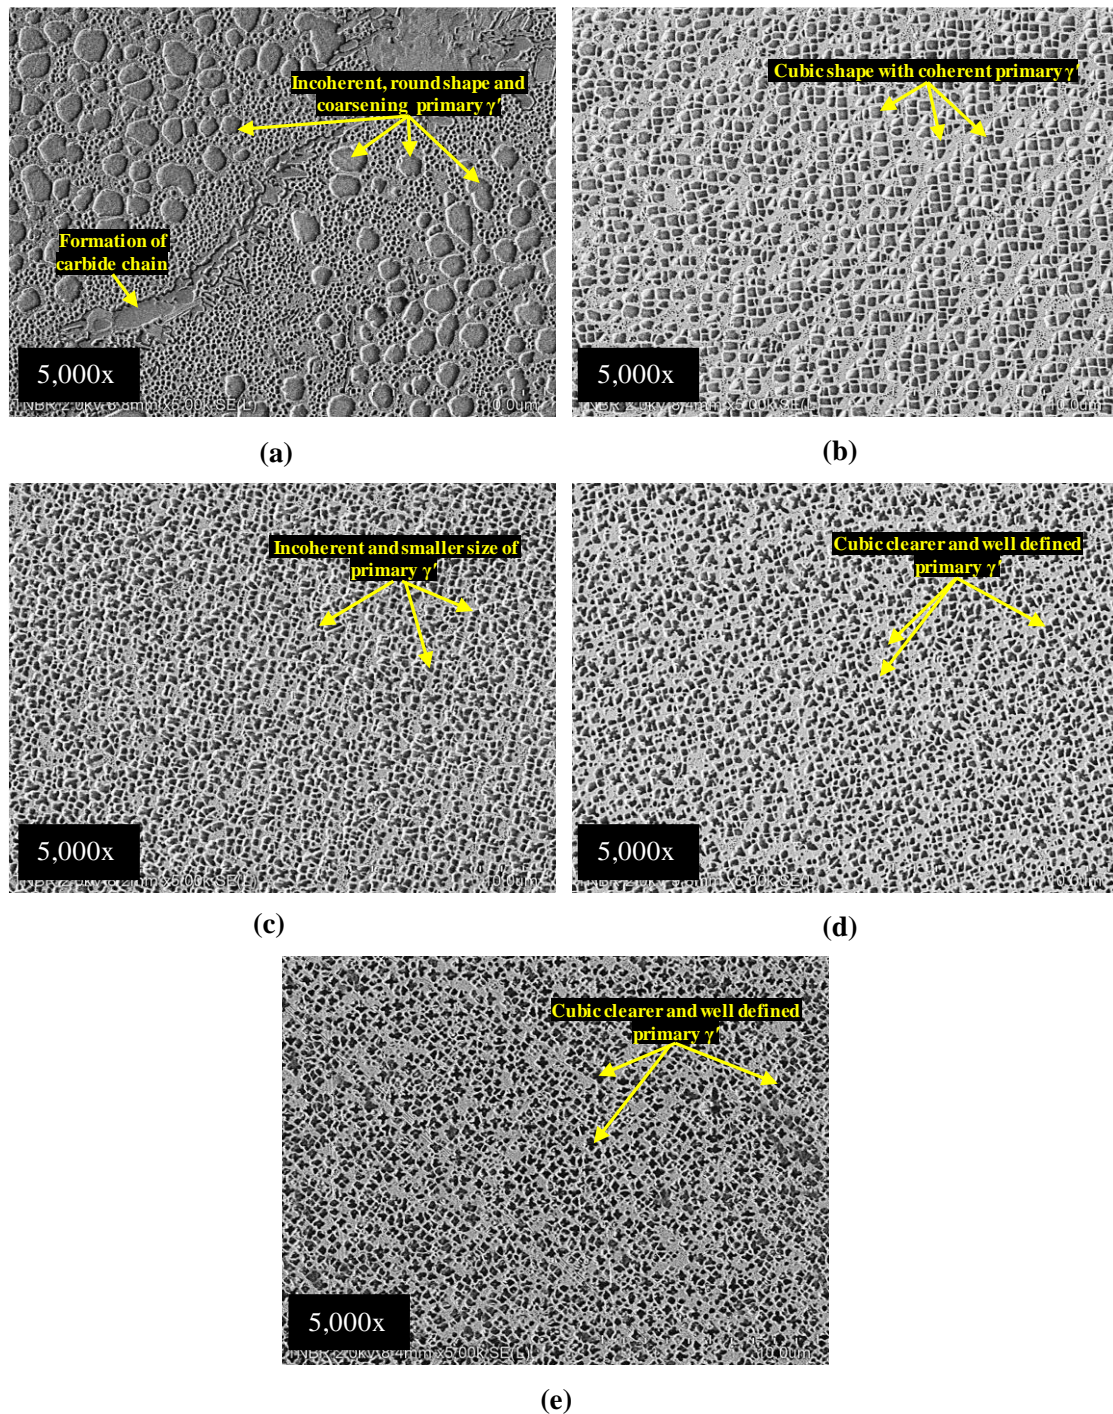
**Microstructure analysis.** Figure 4(a) presents the image of the sample taken from the as-received used blade (service-exposed GTD-111 turbine blade of EQX type with 72,000 EOH). The microstructure consists of incoherent, round shape, and coarsening primary  $\gamma'$ , which are commonly found in materials with prolonged thermal exposure.

The microstructure of the new material consists of cubic shape with coherent  $\gamma'$  precipitates, as shown in Figure 4(b). Figure 4(c) shows the microstructure image of the HIPed used blade using parameter 1, which exhibited incoherent and smaller size of  $\gamma'$  as compared to the as-received used blade. As the HIP temperature increased, it was observed that the shape of primary  $\gamma'$  became clearer and well defined, as presented in Figure 4(d) and (e). The microstructure image of the HIPed used blade using parameter 2 indicated a more defined irregular  $\gamma'$  shape as compared to that of parameter 1, as well as a smaller size of  $\gamma'$  as compared to the as-received used blade. However, it could be observed that used blades treated at 1,220 °C (parameter 3) showed the most optimum conditions in terms of size and shape of microphases, with uniform and aligned  $\gamma'$  in nearly cubical shape as a new material and a smaller size compared to the as-received used blade. Nevertheless, all rejuvenated

blades at 1,191 °C, 1,200 °C, and 1,220 °C were considered successful in the recovery of  $\gamma'$  precipitates to the near-original state, based on the visual appearance under the microscope.

**Figure 4. Microstructure images of (a) used blades before HIP treatment, (b) new materials, (c) Microstructure from used blades by applying HIP treatment using parameter 1, (d) parameter 2 and (e) parameter 3.**

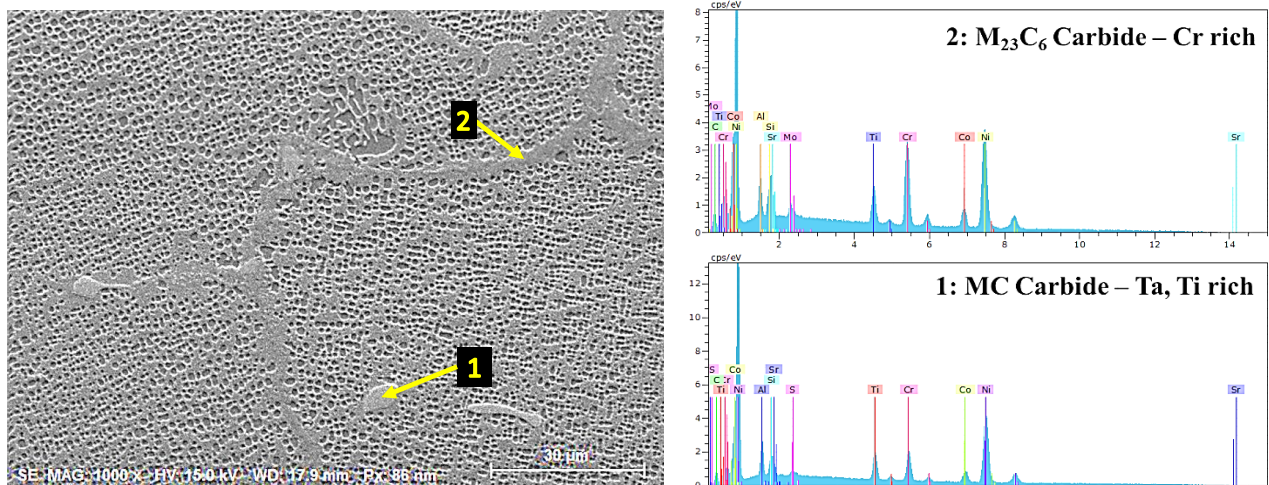
Microstructural changes in a material due to thermal exposure can also cause the decomposition of MC and the formation of M<sub>23</sub>C<sub>6</sub> along the boundary, as depicted in Figure 5 [12, 13]. Figure 5 shows the EDX results for the second-phase precipitates of the as-received used blade. Primary carbide and continuous carbide chains along the grain boundaries were detected using EDX. The microstructural changes may happen due to carbide reaction, where carbon is released during service exposure. The principal carbide reaction leads to the formation of M<sub>23</sub>C<sub>6</sub>, as presented in Equation 1 [4]:

**Figure 5. EDX result for second phase precipitates of used blade as received.**
