## FAILURE INVESTIGATION AND ANALYSIS OF LOCALLY MANUFACTURED TURBINE BLADE

**Abstract.** This study aims to identify the root cause of a turbine blade failure after only 36 hours of operation and recommends measures to prevent future failures. The analysis involved four samples, including an OEM sample, three fabricated samples with cracks and parts, including a kept sample for failure analysis. Microstructural analysis using Villella's reagent as an etchant, surface morphology, and micro-elemental analysis were conducted using the benchtop SEM & EDS. The hardness of the samples was tested using the Rockwell (HRC) method. The failed blade was made of AISI 422 grade stainless steel. It failed due to chipping that initiated cracks when it was tightly fastened, facilitated by internal stress and intermetallic particles in the microstructure. Instead of turbine blades made of hardened steel, the material was found to be slightly ductile and highly prone to compression before breaking when over-tightened during assembly. Inadequate heat treatment practices caused varied microstructural patterns, including the presence of intermetallic particles and significant hardness differences bet

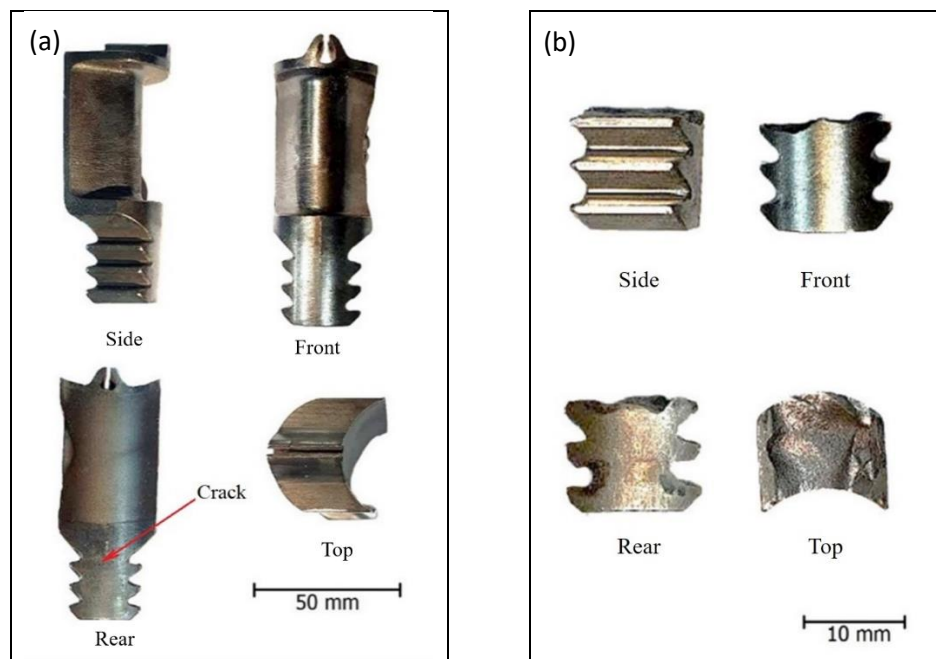
are shown in Figure 1(a) of the cracked sample, while Figure 1(b) displayed the appearance of the parted sample.

**Figure 1:** Camera photograph images of multiple viewpoints (top, side, front, and rear) for (a) cracked and (b) fractured turbine blade samples

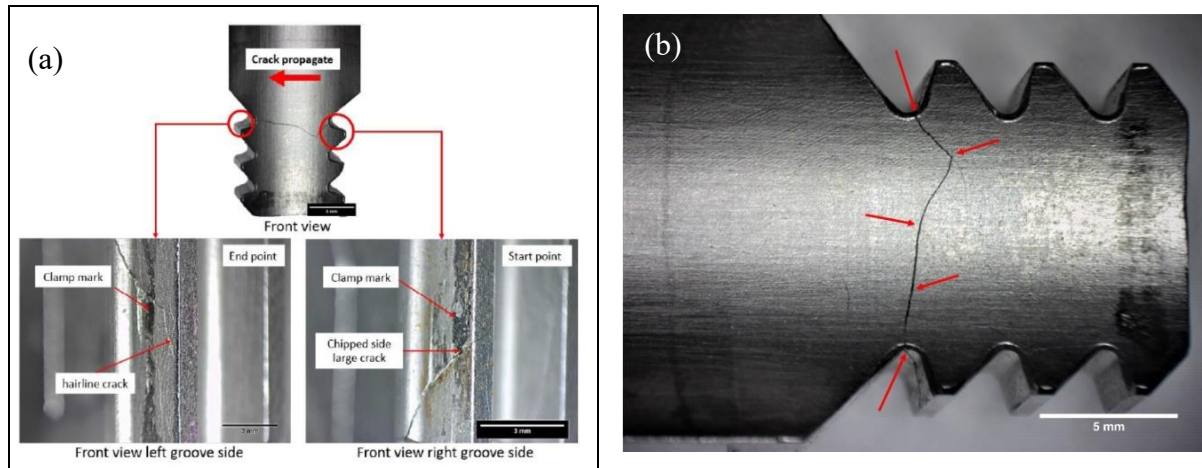
Upon examination using a stereomicroscope, the threaded area surface of the turbine blade revealed a clamp-tightening effect, as depicted in Figure 2. The presence of chip marks on the right side of the blade's groove side indicates that the turbine has been tightened, putting the threaded area under pressure, as shown in Figure 2(a). The formation of cracks is visible in the threaded groove, where the stress is concentrated, with the crack initiating from the chipped area and propagating from the blade's right to the left side (Figure 2(b)). The nature of the crack propagation suggests that the failed turbine blade underwent compression. Further analysis showed that the turbine blade was not composed of fully hardened material, as evidenced by the crack pattern, which is indicative of ductile fracture. The presence of chip signs adds weight to the argument that the failure of this turbine blade is attributed to compression resulting from over-tightening. In addition to compression tightening, the operation that generates tangential forces to rotate the turbine, especially under high temperature and high-pressure gas conditions, facilitated crack propagation. Such tangential forces contribute to the formation and propagation of cracks, which ultimately leads to the failure of the turbine blade.

**Figure 2:** Stereomicroscope image of the cracked sample shows that (a) the crack propagation is visible across the threaded area and (b) crack across the body of the groove side of the turbine blade.

Secondly, to improve the reliability and performance of turbine blades, it is recommended to ensure proper installation with the right amount of force or torque during the tightening process to prevent internal stress [12]. Thirdly, selecting high-quality raw materials is crucial to reduce the presence of intermetallic particles that can serve as crack initiators [13]. This includes using clean and pure raw materials free from sulfur, phosphorus, and nitrogen contaminants. Moreover, it is well known that the handling and processing of raw materials must be carefully monitored to ensure they are not contaminated during storage, transportation, or processing. This can be achieved by implementing proper handling and storage procedures and using dedicated equipment for handling raw materials.

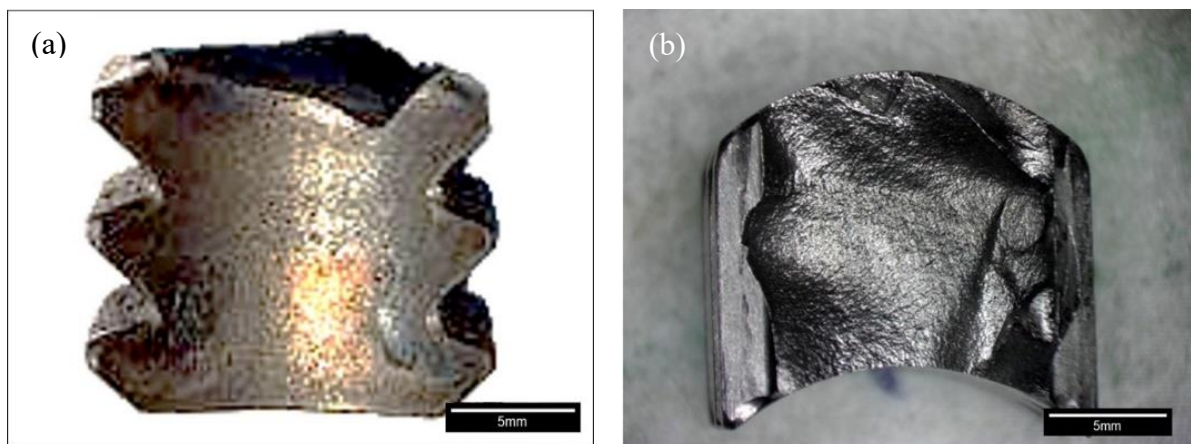
In Figure 3, a close-up stereomicroscope image of the parted turbine blade sample is presented. The image, shown in Figure 3(a), reveals that the fractured pattern of the parted sample is consistent with that of the cracked sample (as depicted in Figure 2(b)). Upon a cross-sectional view, the presence of shear lip features is evident, indicating that the material exhibits ductile fracture properties. This observation provides significant insight into the exact mechanism responsible for the failure pattern of the cracked and parted samples, both of which are fabricated samples. Further analysis of the surface fractography reveals that the fracture grain appears quite dull-rough grey (as depicted in Figure 3(b)). However, the deformation of the material surrounding the fracture is minimal, and the fracture surface seems smooth, with minimal shrinkage. These findings suggest that a significant transverse crack has developed, indicating that the failed turbine blade suffered a slight plastic residual

stress caused by compression due to over-tightening. Taken together, these observations suggest that the failure of the turbine blade was likely caused by a combination of factors, including over-tightening and the resulting plastic residual stress, as well as the material's inherent ductile fracture properties. These findings have important implications for the design and maintenance of similar turbine blades, as they underscore the importance of carefully controlling tightening forces and ensuring that materials are selected based on their specific properties and intended use.

**Figure 3:** Stereomicroscope images on the parted sample: (a) side and (b) top view.

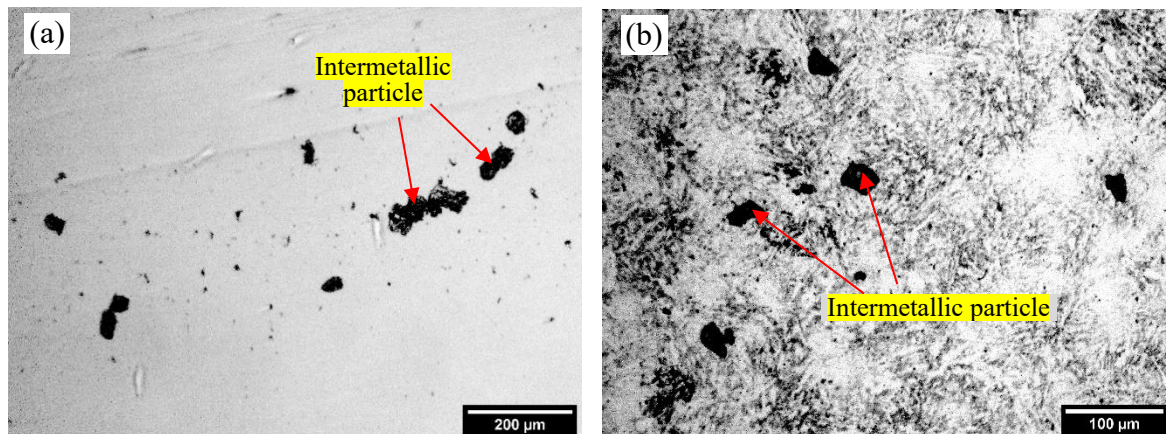
Figure 4 exhibits the microstructure images of the sample that was retained for further analysis. The as-polished kept samples, procured from local manufacturers, displayed intermetallic particles distributed throughout the metal matrix, as shown in Figure 4(a). In general, intermetallic particles can form during the manufacturing process and can negatively affect the mechanical properties of a material. The microstructure of the turbine blade has intermetallic particles that are believed to be composed of both carbides and silicides. However, the identification of these particles will be elaborated in the EDS findings. Upon etching the microstructure, it was observed that the intermetallic particles exhibited an

uneven, irregular, and coarser texture, with ferrite-free areas evident in the tempered martensite structure, as depicted in Figure 4(b). These intermetallic particles are unevenly distributed within the metal matrix. The presence of both carbides and silicides in the microstructure could significantly affect the material's properties and behaviour under stress, as these particles can act as crack initiators and propagate crack growth. This observation suggests that the presence of these intermetallic particles in the metal matrix may contribute to a decrease in the mechanical properties of the material.

**Figure 4:** Optical metallographs of (a) as polished and (b) etched microstructure of the kept sample.

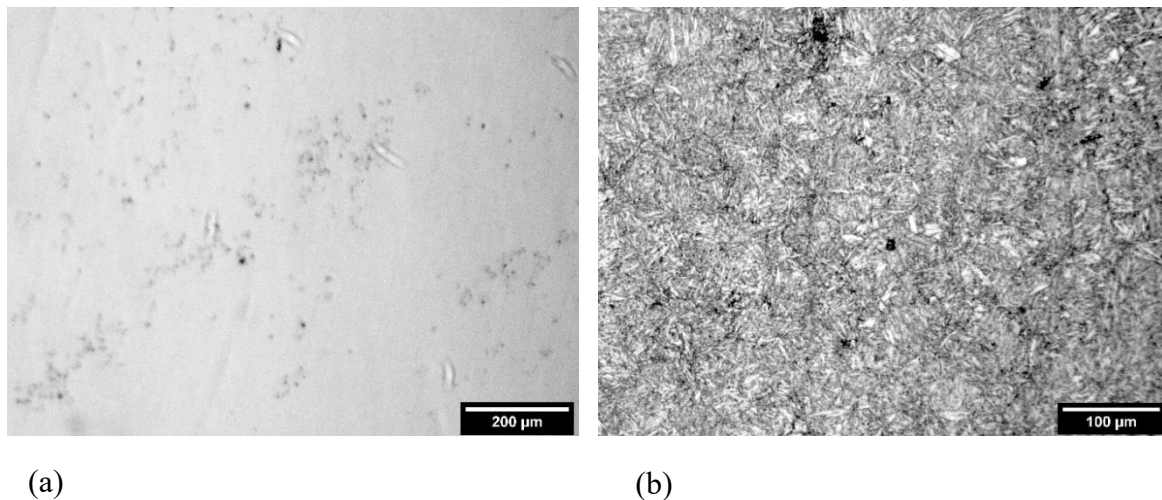
The microstructure of the OEM sample has a relatively smooth hardened stainless-steel structure, as shown in Figure 5. The as-polished microstructure of the OEM sample appeared to have a nearly perfect metal matrix, meaning that the metallic material appeared to have a homogeneous distribution of metal atoms throughout the entire material, without the presence of any voids or defects. Figure 5(a) shows that the microstructure of the OEM sample consisted mainly of a metallic matrix phase. The presence of a few subtle gray spots that appeared more contrasted than the matrix suggests the possible presence of a small amount of intermetallic, although it was not significant enough to affect the overall structure. It is likely that these intermetallic particles did not dissolve completely in the metallic phase during the heat treatment process. The absence of significant intermetallic particles in the OEM sample suggests that the material was manufactured with a high degree of purity and quality control, which is desirable for ensuring the consistent and reliable performance of the material.

The martensite structure of the OEM sample was found to be dense and dominated by fine carbides, with traces of delta ferrite evident, as depicted in Figure 5(b). The traces of delta ferrite would likely appear as distinct regions within the martensitic matrix, with a slightly different colour or texture compared to the surrounding material. The presence of these fine carbides in the microstructure contributed to the material's high hardness and brittleness, making it difficult for cracks to propagate. This observation is particularly significant as it implies that the OEM sample is capable of withstanding high stress conditions without undergoing material failure. Moreover, the presence of fine traces delta ferrite indicates that the sample was annealed after hardening, which effectively reduced residual stress in the material. The microstructure of the OEM sample, which is characterised by its high hardness and minimal intermetallic particles, makes it a promising material for various applications

that require excellent mechanical properties. The fine distribution of intermetallic particles and the presence of fine carbides in the martensite structure of the OEM sample make the material resistant to crack initiation and propagation.

**Figure 5:** Optical metallographs on (a) as polished and (b) etched microstructure of OEM sample.

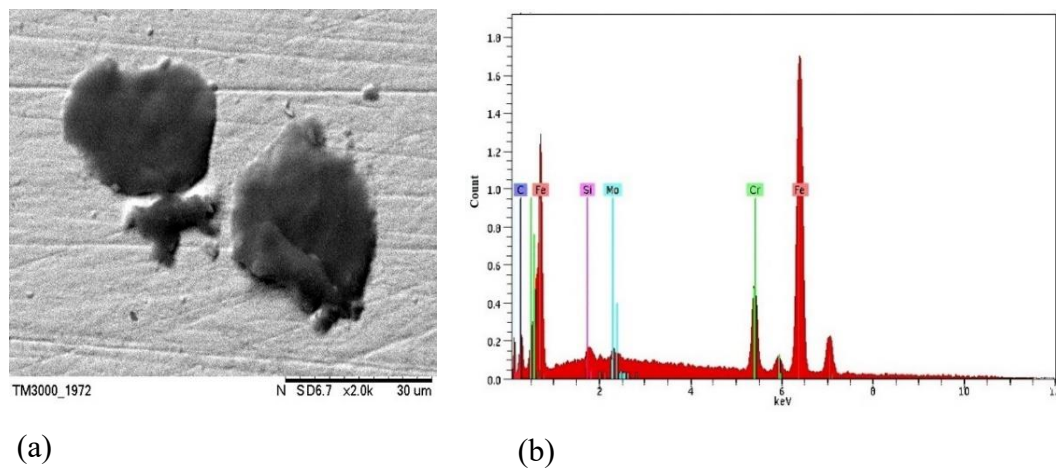
Figure 6 shows the intermetallic particles that are dispersed throughout the microstructure of the kept sample, as observed through close-up SEM analysis in Figure 6(a). Furthermore, Figure 6(b) presents the EDS pattern that display the elemental composition of the intermetallic particles, which comprises of carbon (C), silicon (Si), molybdenum (Mo), chromium (Cr), and iron (Fe). Based on the EDS results, it may suggest that the intermetallic black particles present in the martensite structure of the AISI 422 turbine blade are a combination of carbides and silicides. The 9.68 wt.% carbon detected in the EDS pattern indicates the possible formation of commonly found carbides in martensitic stainless steels, such as chromium carbides ( $\text{Cr}_3\text{C}_2$ ) or iron-chromium carbides ( $\text{FeCrC}$ ). In addition, the presence of silicon in the EDS pattern also suggests the formation of silicides, including chromium disilicide ( $\text{CrSi}_2$ ) or ferrosilicon ( $\text{FeSi}$ ). Nonetheless, the exact identity of these intermetallic particles remains inconclusive in this study. Thus, a more comprehensive analysis, such as X-ray diffraction or transmission electron microscopy, is necessary to determine their precise composition.

The OEM sample contains the same elemental components as the kept sample, with a comparable concentration. However, the significant difference between the two samples lies in the fine distribution of intermetallic particles in the OEM microstructure. Therefore, the observed variations in microstructural patterns between the OEM and kept samples are not due to differences in their chemical composition. Instead, manufacturing imperfections such as ladle casting procedures and heat treatment could have contributed to the formation of intermetallic solid particles in the stainless steel and different martensite structural patterns. It is believed that the imperfection of the heat treatment process plays a significant role in the production of intermetallics and the formation of martensite structures that have areas devoid of free-ferrite.

**Figure 6:** (a) SEM micrograph of intermetallic particles in the failed turbine blade and (b) EDS results of the elemental composition of the intermetallic particles.

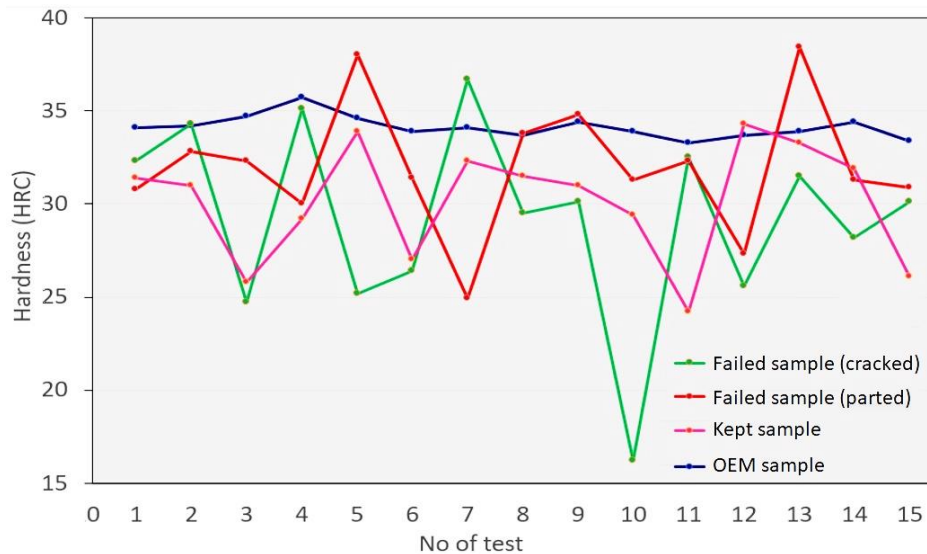
The results presented in Figure 7 reveal some significant differences between the hardness values of the OEM turbine blade samples and the locally fabricated samples. The hardness readings for the OEM samples were found to be consistent across all the samples, indicating that they were subjected to a uniform heat treatment process, resulting in a consistent microstructure. On the other hand, the hardness readings for the locally fabricated samples, both the failed and kept samples, showed significant fluctuations. This variation in hardness can be attributed to the uneven microstructural patterns, indicating the presence of residual stresses resulting from conflicts in the heat treatment practices used during fabrication. Therefore, it can be concluded that the locally fabricated turbine blade is not comparable to the OEM sample due to the differences in their microstructure and hardness values. While the casting technique used in the fabrication process may not have been the source of the problem, it is clear that the heat treatment procedures employed in the local fabrication must be reviewed and optimised to ensure that they are comparable to the OEM turbine blade. Such a review and optimization of the heat treatment process will help ensure that the microstructure and hardness values of the locally fabricated turbine blades are consistent and comparable to those of the OEM sample, thereby improving the quality and reliability of the locally fabricated turbine blades.

**Figure 7:** Rockwell hardness profile (HRC) turbine blade samples

As a recommendation, to obtain perfect, fully hardened stainless steel and reduce the risk of cracks or fractures, it is necessary to focus on several critical aspects, including the casting process, heat treatment, raw materials, and quality control. In this response, there are a few recommended preventive actions to be further insights on achieving the desired outcome. Firstly, to ensure the quality of the final product, it is crucial to remove all slag and dross during the casting process to prevent non-metallic inclusion contamination [10]. These contaminants can initiate cracks and lead to premature failure. Good casting practices, such as controlling the temperature and avoiding turbulence during the pouring process, should be implemented to prevent the formation of non-metallic inclusions. Additionally, to meet the operational requirements of the metal/alloy, the microstructure of the material should be designed accordingly. This can be achieved through advanced manufacturing techniques such as directional solidification and innovative heat treatment procedures, including quenching and tempering, to achieve the desired martensite microstructure and properties [11]. These measures can enhance the material's mechanical properties, minimise the risk of turbine blade failure, and increase the reliability and efficiency of the turbine operation.
