## ROOT CAUSE ANALYSIS ON MANUFACTURING DEFECTS IN BRASS OXYGEN VALVES

**Keywords:** Brass valve, hot-forging, failure analysis, dross, cracks

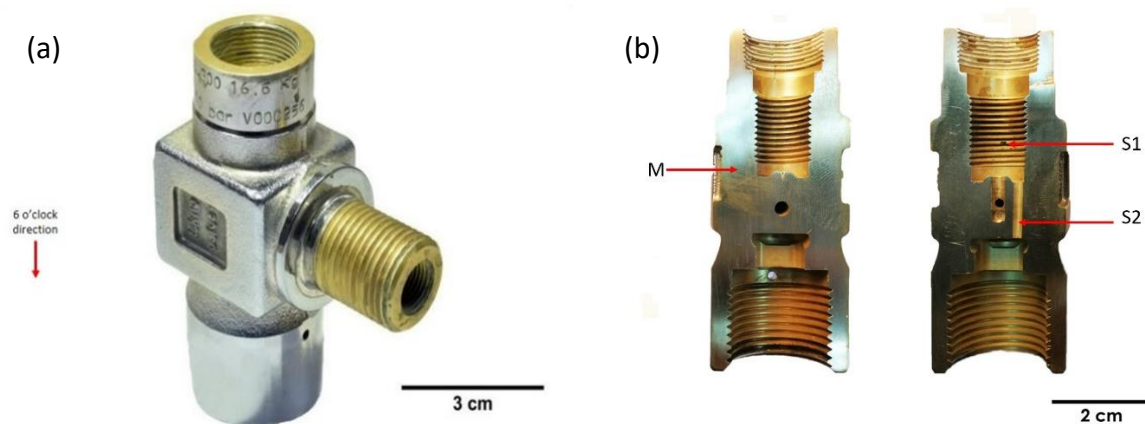
A visual inspection of a failed brass valve's as-received condition was documented using a digital single-lens reflex (DSLR) camera (D3100, Nikon), as shown in Figure 1. The failed oxygen valve sent in for failure analysis was a brass valve with chrome plating, as shown in Figure 1(a). The brass valve was bisected using a diamond cutter at the slowest speed (200 rpm) to ensure that no external residual stress was applied to the brass valve, as shown in Figure 1(b).

**Figure 1:** Camera photograph of (a) as-received, and (b) bisected brass oxygen valve.

A stereomicroscope was used to perform a close-up examination of the cracks at the S1 and S2 locations shown in Figure 1(b). The bisected sample was then ground with SiC grit paper of varying grit sizes, including 180, 240, 320, 440, 800, and 1200, before being polished with diamond solution to 6  $\mu\text{m}$ . The as-polished sample was observed using a metallurgical microscope (BX41, Olympus). The metallurgical microscope observations provided further insights into the nature of the defects at the location labeled M in Figure 1(b) to identify the presence of defects such as cracks, voids, and porosities. Additionally, metallographic observations on as-polished billet samples were conducted at random specified locations for comparison purposes. To study the existence of fine cracks, inclusions, pinholes, and/or any microstructural abnormalities in greater detail, the valve metal matrix was repolished using 1  $\mu\text{m}$  diamond solution and 0.3  $\mu\text{m}$  alumina suspensions. The repolishing of the valve metal matrix with diamond and alumina suspensions enabled a more

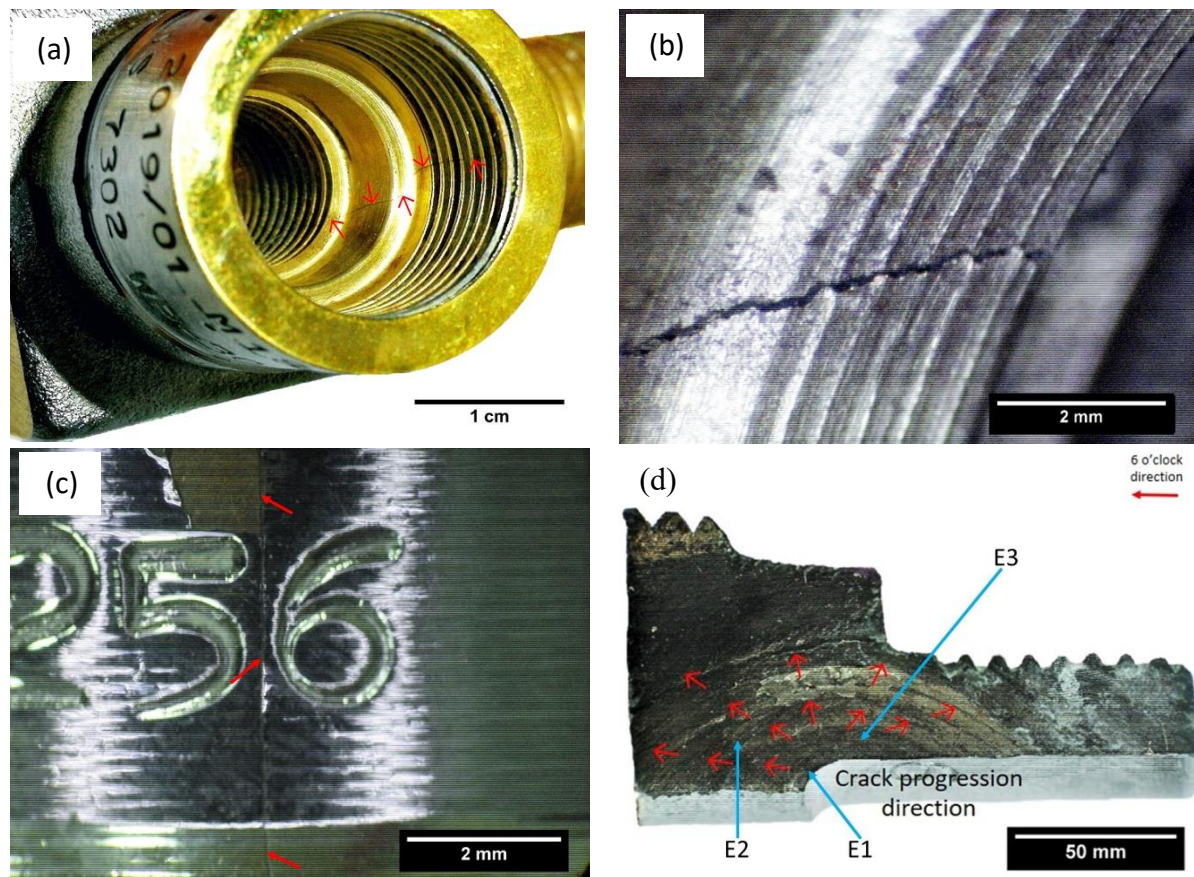
Figure 2 depicts the results of a visual inspection of the brass oxygen valve sample, which provided valuable information about the condition of the valve. Upon close examination, it was found that there were vertical hairline cracks present on the female thread shallow zone of the valve wall, as indicated by the red arrows in Figure 2(a). In addition, there was an unequivocally opening crack detected in the deeper wall zone that propagated at an angle of 45° (Figure 2(b)). These cracks could have been caused by stress concentration due to the threading process or by the application of excessive torque during the installation of the pneumatic test cock/ insert.

Furthermore, a hairline crack was also detected on the exterior body at the chrome-plated area, which suggested that the crack had extended across the valve wall (Figure 2(c)). This observation highlights the importance of inspecting the entire valve structure, as defects in one area can often lead to more significant issues elsewhere. The presence of these cracks indicates that the valve had been subjected to excessive stress, likely due to the high-pressure environment in which it operated. Taken together, these findings indicate that the applied air pressure during the pneumatic test was able to escape via the tiny openings in the cracks. This not only compromised the integrity of the valve but also posed a significant safety risk, as leaks in oxygen valves can be highly dangerous.

Upon bisecting the valve sample, it was discovered that a portion of the valve wall structure was easily detached, indicating that the crack had fully severed the solid bulk structure of the valve wall. Upon closer inspection of the fracture surface, a progressive crack was found to have initiated on the outer side of the valve wall and grown inward, as evidenced by the red arrow in Figure 2(d). The presence of this progressive crack raised the possibility of two potential causes: a forging crack or metal fatigue. However, since the valve had not yet been put into service, the argument for a forging crack was more convincing. This was because the cracking patterns resembled fatigue striations that were expected to be produced from the inward mechanical stress progressively generated during the forging process. Therefore, the possibility of failure due to metal fatigue could be ruled out. This argument was further supported by the valve's design, which featured a curvy shape that could serve as a starting point or stress riser for the appearance of cracking during forging. However, in order to ensure a thorough investigation, evidence or indications to refute the presence of fatigue failure were also explored through SEM observation at points E1, E2, and E3. These points will be described in greater detail below. Overall, the investigation revealed that the progressive crack observed on the valve wall was likely caused by a forging crack rather than metal fatigue.

**Figure 2:** Visual inspection photographs demonstrate the defective marks on the (a) shallow and (b) deeper female thread walls zone, (c) the external body at the chrome-plated area, and (d) the fractured surface on the detached valve body section

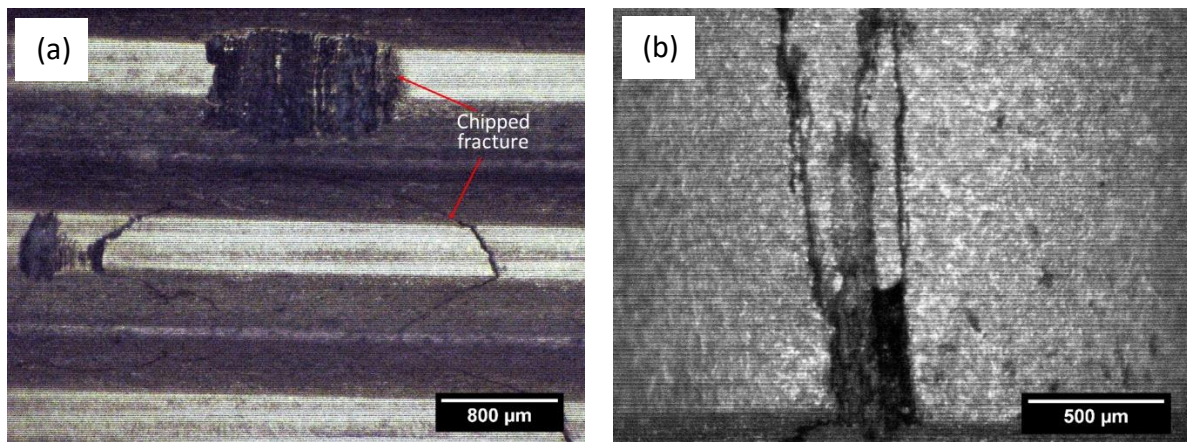
Figure 3 shows a stereoscopic micrograph that illustrates the behavior of crack propagation at locations S1 and S2 (refer to Figure 1(b)). Upon close examination of the thread area at the S1 location, it was observed that there were indications of chipped fractures that had been detached from the thread structure (Figure 3(a)). Another similar sign of the nearby crack appearance was also detected, but it had not yet detached away from the thread structure. This circumstance demonstrated that the brass valve appeared to be made of a material that was prone to breakage easily. In addition, Figure 3(b) depicts a digitally enlarged stereomicroscope image of the cracked region in the S2 location (refer to Figure 1(b)). The observations indicated that the S2 region had branching cracks and chipped breaks. This branch crack showed that the valve was under excessive pressure. Meanwhile, the existence of chipped cracks indicated that the valve's material was less ductile, implying that the material still had some degree of ductility, but it was reduced due to the nature of the brass material. The combination of these findings suggests that the brass valve had been subjected to excessive stress, likely due to the high-pressure environment in which it operated. This is consistent with the presence of the cracks observed in earlier inspections.

**Figure 3:** Stereomicroscope images along the defective area on (a) S1, and (b) S2 locations.

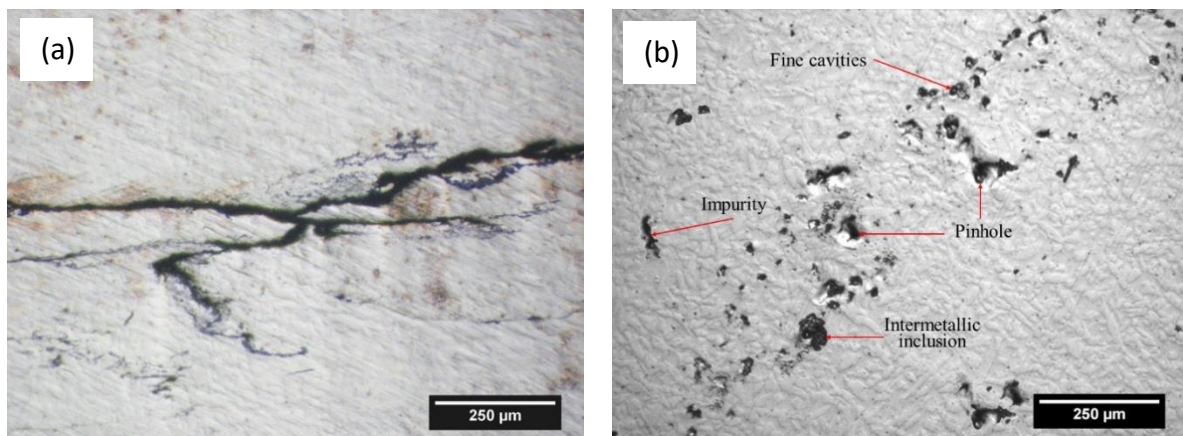
The image presented in Figure 4 displays the observation made through a metallurgical microscope on the as-polished sample at location M (as depicted in Figure 1(b)). The low magnification view of the sample revealed that there were multidirectional cracks

present in the brass matrix as shown in Figure 4(a). Furthermore, it was noted that the polishing process used during this stage left behind some stain or dirt that was challenging to remove. Upon observing the as-polished sample on the billet, intermetallic solid inclusions, impurities, pinholes, and fine cavities were identified in the brass matrix (Figure 4(b)). However, there was no evidence of cracks present in the studied billet matrix. It was noted that the microstructural imperfections in the form of dross in the billet were visible at low magnification. Dross is produced when molten metal is exposed to air and can have a detrimental effect on the mechanical properties of the metal. As a result, even a small amount of stress can cause the valve material to crack or fracture due to the presence of these dross imperfections.

**Figure 4:** Optical metallographs of the as-polished sample surface at lower magnification; (a) failed valve and (b) brass billet

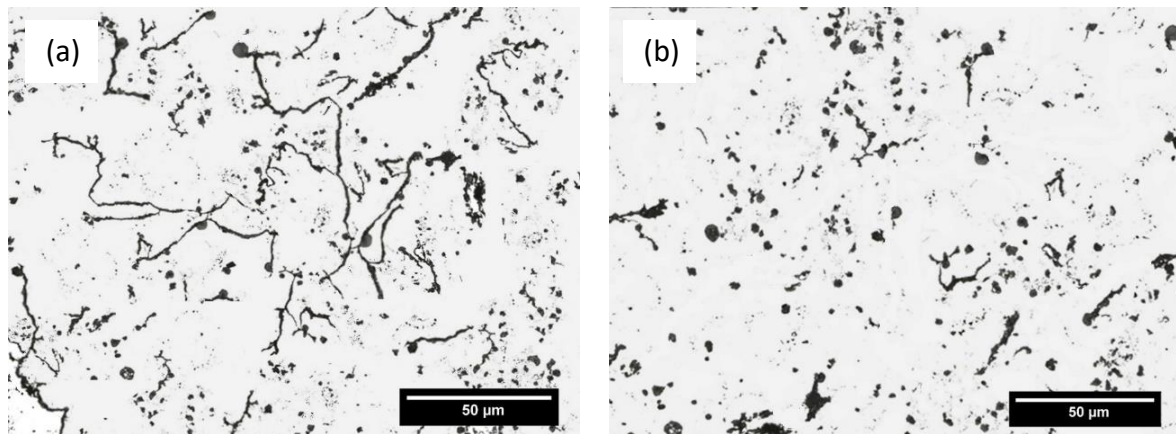
The metallurgical microscope images presented in Figure 5 provide a comprehensive and detailed view of the as-polished valve sample. The findings reveal the presence of fine dark scars and foamy dark surfaces with irregular shapes that are distributed throughout the brass valve matrix. These imperfections appear to result from multidirectional microcracks arising from residual stresses after forging, which could have been further exacerbated by

subsequent machining. The propagation of the cracking through both fine-rounded cavities and intermetallic inclusions with irregularly shaped cavities is indicative of the presence of solid or porous oxide, as well as air inclusions or dross that likely originated from the brass billet. The argument regarding the presence of dross in the brass billet is further substantiated by the metallograph image depicted in Figure 5(b), which displays a similar topography as observed in Figure 5(a). The absence of cracks in the billet matrix provides further confirmation that the cracks on the failed valve were most likely caused by the secondary and tertiary processes such as hot forging and pneumatic testing.

**Figure 5:** Optical metallographs of the as-polished sample surface at higher magnification; (a) failed valve and (b) brass billet

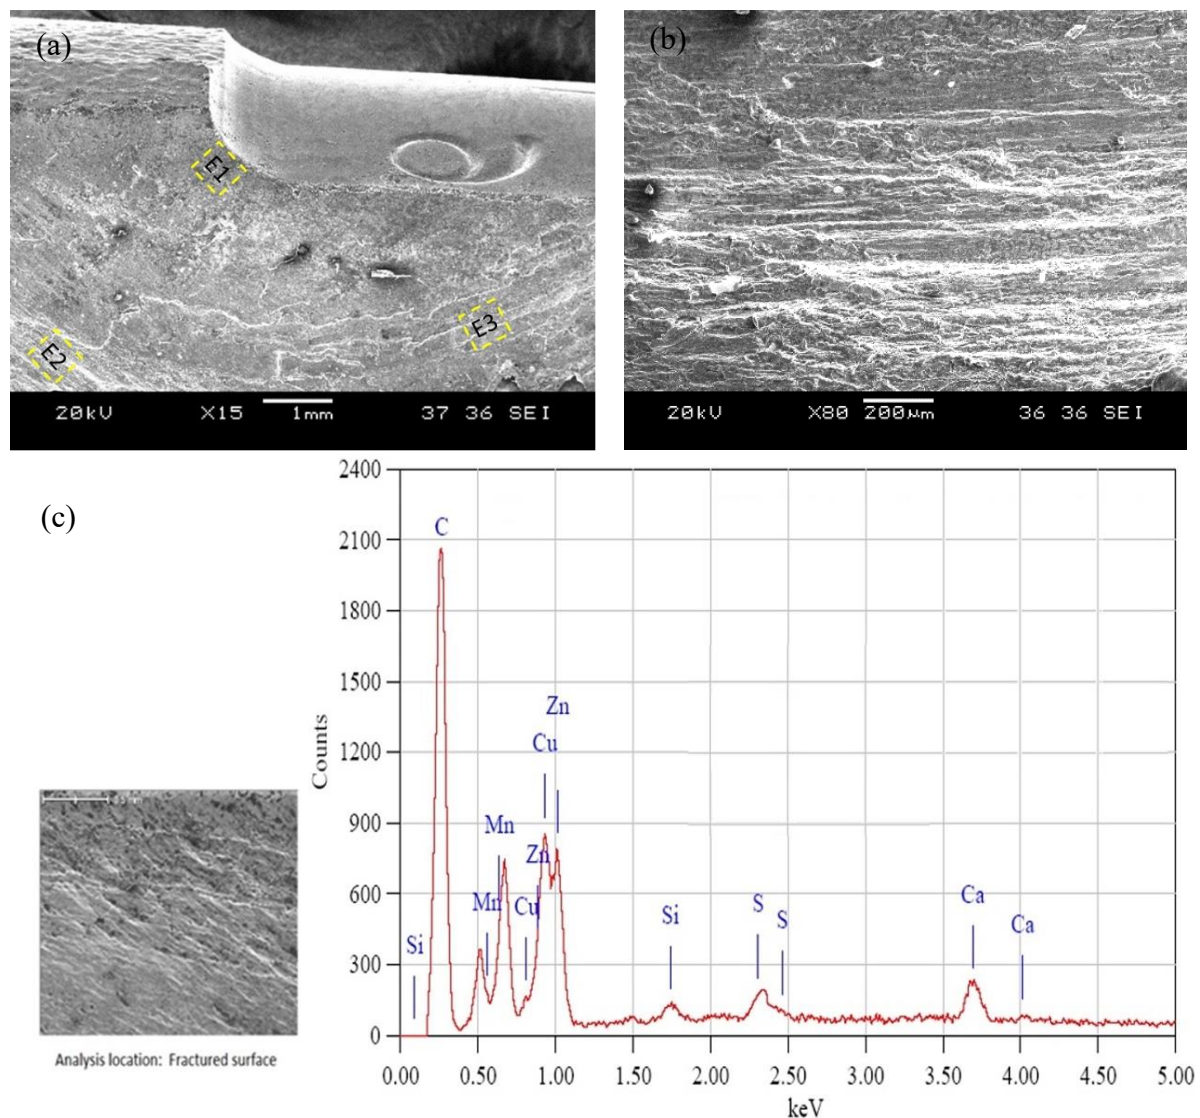
Microanalysis results from SEM and EDS are displayed in Figure 6. The analysis was conducted to study the possibility of fatigue failure on the failed valve. There are three stages of fatigue failure, i.e., initiation, propagation, and final fracture. The analysis of SEM-EDS focuses on the results from the first and second stages only. The first stage, which is the initiation stage, allows to investigate the area where the progressive crack starts. The point where a crack starts can be very small and hard to figure out from the subsequent stages of crack propagation. Most of the time, grinding and machining marks, corrosion pits, non-metallic inclusions intersecting the metal surface, scratches, or notches are what cause fatigue to start. Conversely, because the initiation point is always parallel to the direction of stress, the curvy design of the valve is supposed to be the root cause of the excessive mechanical stress given to that zone during forging. As for this present study, the crack was observed to start near the curved area (Figure 2(d)). However, no obvious indicators of a

crack initiation point were observed in the E1 point (Figure 6(a)).

In addition, the SEM image of E2, which was presumed to be the result of fatigue failure, indeed resembled a striation structure (Figure 6(b)). However, this assumption can be denied since the failed valve sample had not yet been used in operation by the user. Consequently, this fractography surface can be suggested to originate from a crack propagation due to the high air pressure present during pneumatic testing. It was believed that the blackish-dark color of the fractured surface (Figure 2(d)) was due to the oxidation interaction with the chrome plating chemicals and continued during the storage period. This changed the surface from its original, which was probably in a quite shiny condition.

**Figure 6:** SEM micrographs of the failed valve sample analysed using SEM-EDS to investigate the possibility of fatigue failure. (a) The analysis points to the fracture surface at the curvature area, showing E1, E2, and E3. (b) Enlarged image of the striation-like structure at E2 and (c) EDS micro-elemental analysis result at E3

The EDS pattern at point E3 on the fractured surface is depicted in Figure 6(c). The brass matrix was composed predominantly of Cu, Zn, and a small portion of Mn as an alloying element. Mn is known to readily form intermetallic solids with other metals. Referring to the Table 1, this brass valve also contained Pb. However, Pb could not be identified by EDS because its energy levels exceeded the EDS detection threshold. In addition, the surface of the fracture was composed of C, S, and Ca elements. The presence of C was most likely the contamination detected in the EDS analysis of surface composition. It may also be present because of carbon-related gas reactions in the storage environment. Ca was considered to have been added to the molten brass as a casting additive or flux, while S was believed to have originated from the furnace environment.

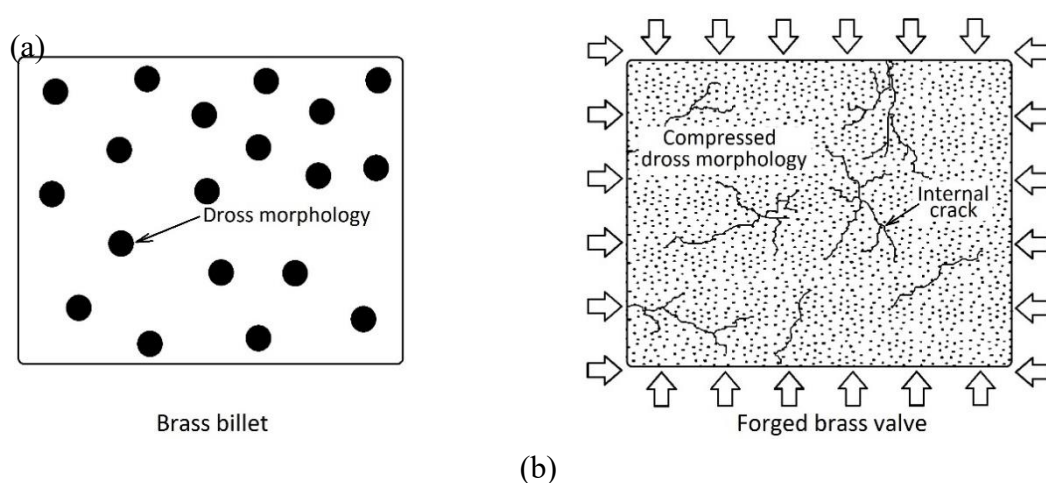
contraction of the metal, which can result in cracking. In the present investigation, the forging process was carried out within the appropriate temperature range. However, assessing the actual operation at the site posed a challenge. It is important to note that accurate control of the forging process parameters is crucial to minimize the formation of forging cracks. The parameters include the forging temperature, the deformation rate, and the degree of deformation. Proper forging techniques can prevent the occurrence of forging cracks by ensuring that the metal remains within its ductile temperature range during the deformation process. The design of the product is also a critical factor in preventing forging cracks. The shape of the product should be designed to minimize stress concentrations, as stress concentration points are more likely to lead to the formation of cracks. Additionally, the starting material should be of high quality and free from defects that could lead to cracks during the forging process.

**Figure 7:** Schematic diagram illustrating the effect of microstructure on failed brass valves (a) before and (b) after hot forging

As a preventive measure, several techniques can be employed to reduce the amount of dross present in the initial brass billet. One approach involves carrying out the melting process with an additive or flux, either in a vacuum or in an inert environment, which can lower the amount of dross formation. Another method is to add one or more supplementary components to the mixture before pouring the molten metal into the billet mold, causing the dross to rise and float to the surface, where it can be easily removed by skimming. If these techniques are ineffective, specialized ladles that allow the metal to be poured from the base can be utilized. Additionally, ceramic filters can be implemented into the gating system to trap impurities before the metal enters the mold. Alternatively, swirl gates can be constructed, which swirl the liquid metal as it is poured, forcing lighter inclusions to the center of the casting, and preventing them from being cast [3,15].

Reducing dross formation in the initial billet is crucial since it can significantly impact the quality of the final product. Dross is an undesirable byproduct of the melting process that can contain impurities, such as oxides, that weaken the strength and durability of the brass. Furthermore, dross can cause defects in the casting, such as porosity, which can compromise its structural integrity. Therefore, it is vital to implement effective strategies to minimize dross formation in the initial billet. By using additives or fluxes during the melting process, or by employing specialized equipment such as ladles, ceramic filters, or swirl gates,
