FAILURE ANALYSIS OF NATURAL GAS FUEL SUPPLY TUBES IN POWER PLANT COMBUSTION SYSTEMS

Abstract. Failures in natural gas fuel supply systems are often linked to the combined effects of material degradation, operational factors, and improper installation practices. In this study, the primary cause was identified as an installation error at the tube bend, leading to condensation-induced corrosion. Rapid temperature and pressure fluctuations during shutdowns created ideal conditions for moisture accumulation, particularly at the bend, which accelerated corrosion. The failure mechanisms involved stress corrosion cracking (SCC), sulfide stress cracking (SSC), hydrogen embrittlement (HE), and localised pitting corrosion. The presence of hydrogen sulfide (H₂S) and trace amounts of chlorides in the natural gas further intensified the degradation. The methodology included visual inspection, chemical composition analysis, stereomicroscopy, optical microscopy, scanning electron microscopy (SEM), and energy-dispersive spectroscopy (EDS). These analyses identified the extent of condensation-induced corrosion and the failure points. Results confirmed that the tube bend geometry contributed to mois

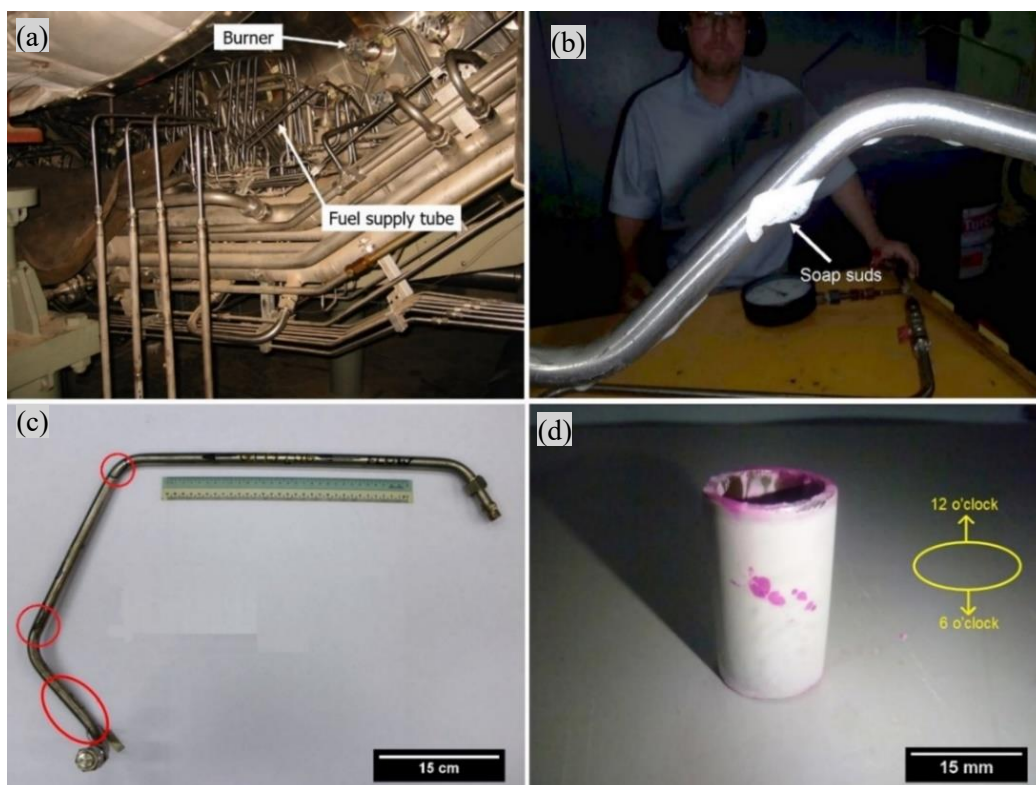
Figure 1 shows camera photographs of the leak investigation. A site visit was conducted to assess the fuel gas supply tubes connected to the combustion system. Initial visual inspection (Figure 1(a)) revealed no visible leaks; however, a soap bubble test identified multiple leaks along the straight section near the bend (Figure 1(b)). The leaks were predominantly localised at the 6 o'clock position (Figure 1(c)), while the bend itself showed no visible defects. Dye Penetrant Inspection (DPI) confirmed surface-breaking flaws at these locations (Figure 1(d)).

The absence of leaks at the bend contrasts with typical SCC initiation at geometric stress concentrators, as observed by Radhakrishnan et al. [8]. Instead, leakage at the straight section aligns with gravitational water settling, as noted by Ajayi and Lyon [9], where stagnant condensate accelerates localised corrosion. Pitting corrosion is proposed as the primary failure initiator, as prolonged exposure to moisture and chloride diffusion likely caused passive film breakdown, creating sites for crack nucleation. This hypothesis is supported by EDS analysis (Section 3.4), which confirmed chloride and sulfur deposits at the failure sites.

Figure 1: Camera photographs of the leak investigation: (a) Overall tube condition, (b) Soap bubble test, (c) Marked leak locations and (d) DPI confirming leakage at the 6 o'clock position

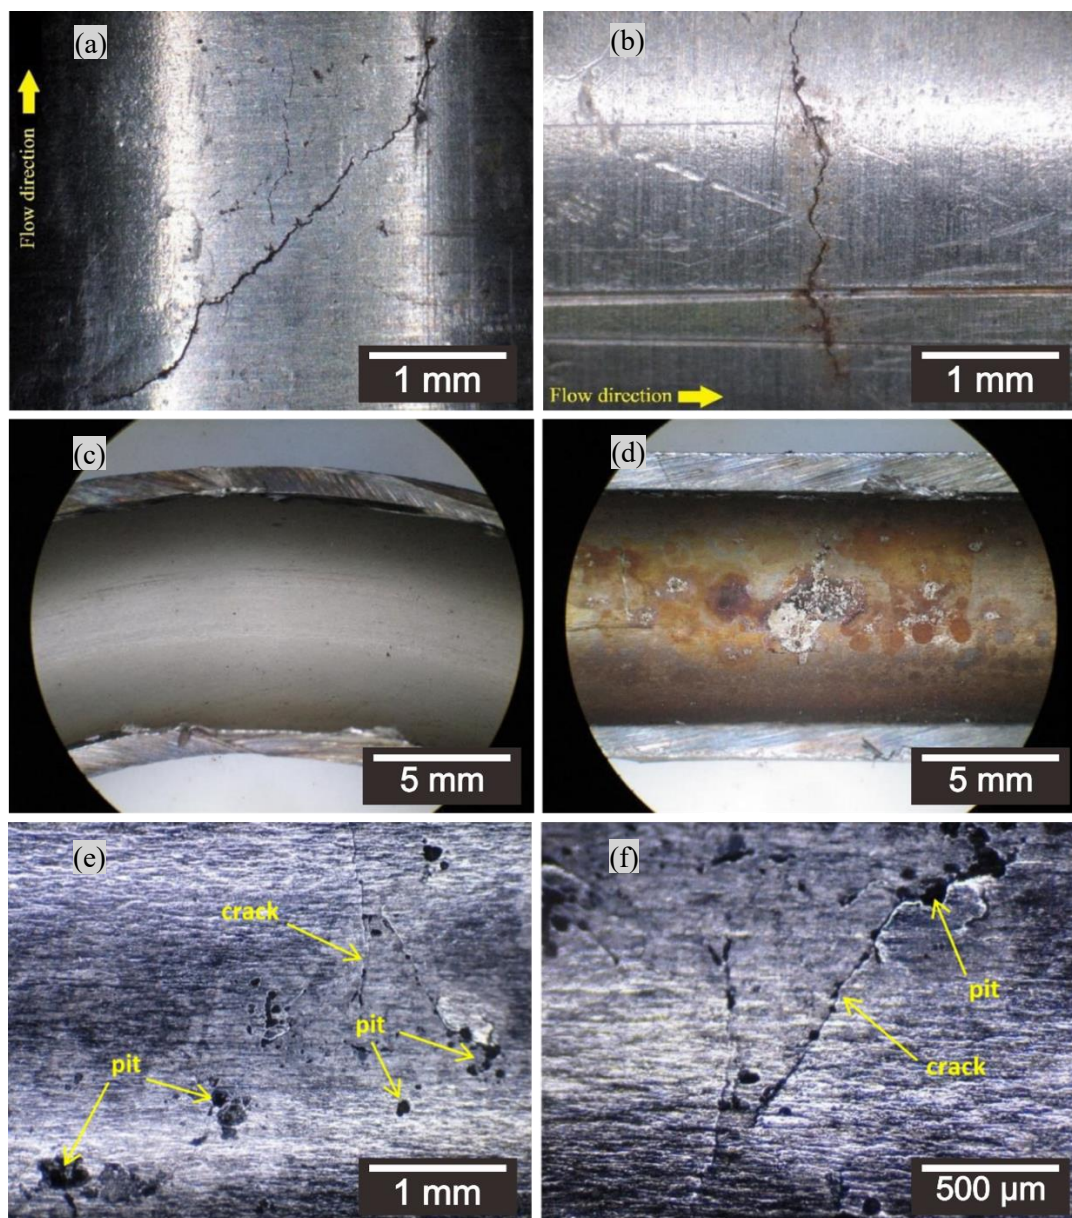
Stereomicroscope analysis revealed critical insights into the failure mechanism, with distinct crack patterns and corrosion damage observed on both external and internal tube surfaces (Figure 2). The outer surface (Figure 2(a)) exhibited a primary crack propagating diagonally at approximately 45°, accompanied by multiple secondary branching cracks along the grain boundaries. These morphological

features are characteristic of brittle fracture behaviour, often associated with high tensile stresses, low operating temperatures, or exposure to corrosive species that weaken the metal matrix, as reported by Yu et al. [12]. The presence of secondary cracks indicates localised stress concentration zones that accelerate corrosion penetration and structural weakening, consistent with observations by Alhede et al. [15].

Figure 2: Stereomicroscope macrographs of the failed fuel supply tube showing (a) primary and secondary cracks, (b) a perpendicular crack, (c) a clean bent section, (d) rust at the 6 o'clock position, (e) pitting on the outer surface, and (f) pitting with cracks on the inner surface

SCC was evident, emphasising the role of tensile stresses in accelerating degradation in corrosive environments, as observed by Hamdan et al. [13]. The internal surface showed corrosion-driven damage, with aggressive species (e.g., chlorides and sulfide ions) weakening the passive film. The bent section (Figure 2(c)) appeared macroscopically defect-free, consistent with findings that bending did not induce visible damage. However, the straight section at the 6 o'clock position (Figure 2(d)) displayed brownish corrosion products, indicating a localised attack. Pitting corrosion was observed on both outer (Figure 2(e)) and inner (Figure 2(f)) surfaces, with cracks initiating near pits. This supports pitting as a precursor to structural failure, as pits act as stress concentrators for SCC. The

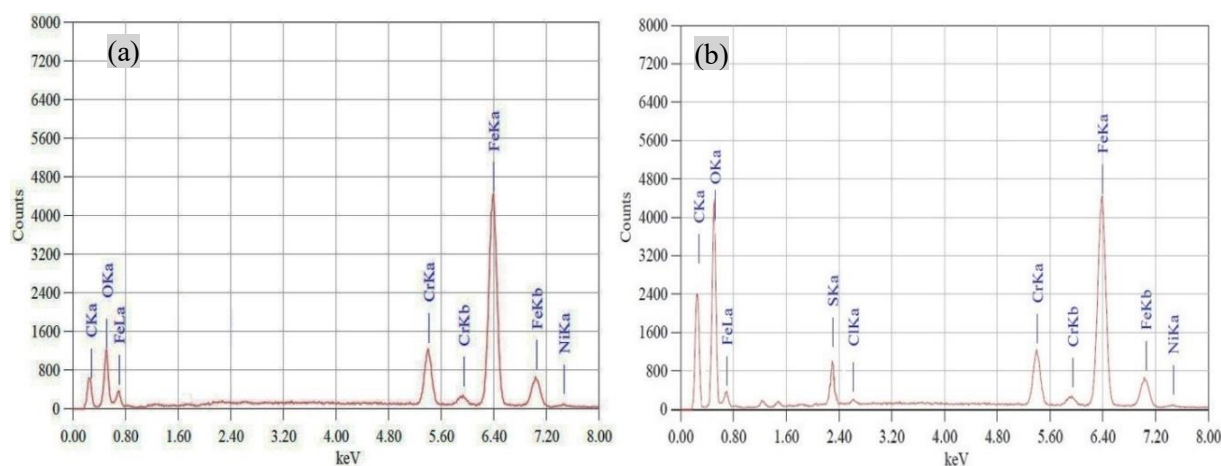
Figure 3 presents EDS spectra from two regions of the failed fuel supply tube, providing insights into elemental composition and corrosion mechanisms. The EDS spectrum of the base metal (Figure 3(a)) shows dominant peaks for iron (Fe), chromium (Cr), and nickel (Ni), consistent with AISI 304 stainless steel composition. Minor oxygen (O) and carbon (C) signals suggest surface oxidation or contamination, aligning with Latypova & Latypov's [14] observations of similar surface phenomena in stainless steels. In contrast, the EDS spectrum of the corrosion deposits (Figure 3(b)) reveals Fe, Cr, and Ni, alongside notable sulfur (S) and oxygen (O) peaks, and a weak chlorine (Cl) signal. These elements are critical to corrosion mechanisms: Sulfur (S) indicates SSC, typically linked to hydrogen sulfide (H_2S) exposure in wet environments [11]. Whereas, chlorine (Cl^-), even at low concentrations, aligns with established links to pitting corrosion in stainless steels [1,10].

Figure 3: EDS patterns of the internal tube wall at (a) the unaffected bend and (b) the corroded straight section

The coexistence of S and Cl^- suggests a synergistic degradation mechanism, where H_2S promotes SSC while chlorides accelerate pitting and passive film breakdown. This aligns with prior studies linking material susceptibility (e.g., AISI 304's low molybdenum content) to localised corrosion in aggressive environments [1,10].

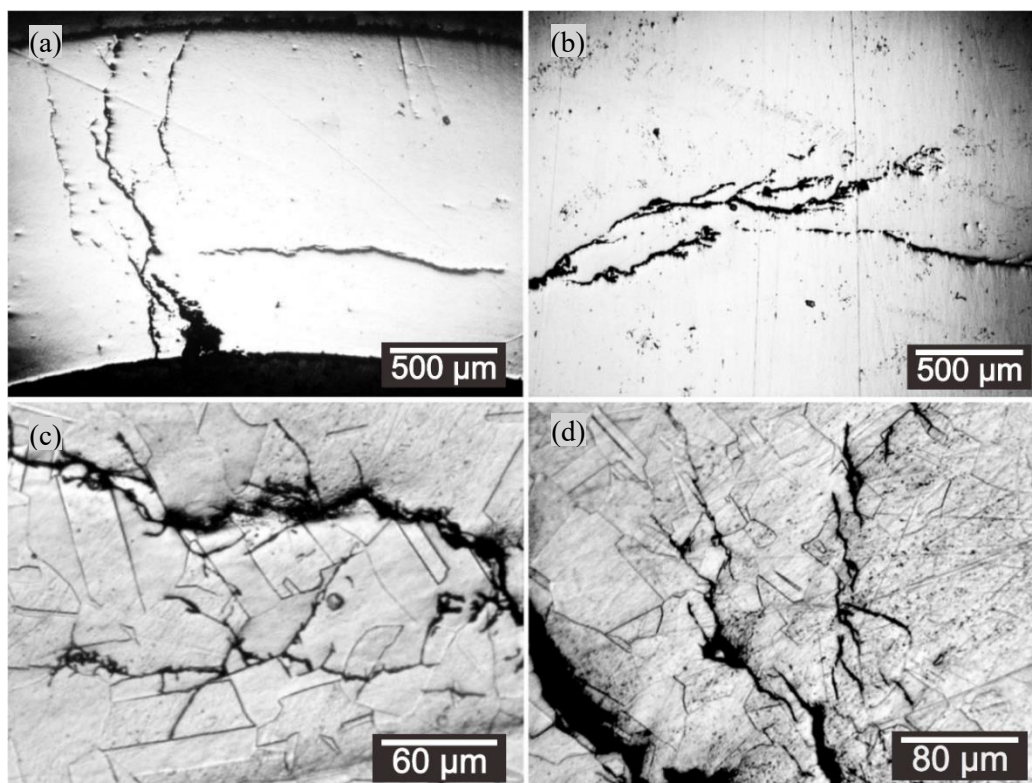
Microstructural analysis was conducted to examine the crack propagation behaviour and the extent of material degradation in the failed natural gas fuel supply tube. Figure 4 presents a comparative evaluation of both as-polished and etched microstructures, revealing critical evidence of the underlying failure mechanisms and their progression over time. The as-polished micrographs (Figures 4(a)–(b)) clearly show cracks initiating from the inner surface and propagating outward toward the tube wall, consistent with corrosion-assisted degradation originating from the internal environment where condensate and corrosive gases were trapped.

The transverse section (Figure 4(a)) highlights multiple pits acting as micro-stress concentrators, supporting the conclusion that pitting corrosion served as the primary initiation factor for subsequent cracking and material loss. The longitudinal section (Figure 4(b)) exhibits a complex, branched cracking morphology, characteristic of brittle fracture mechanisms associated with stress corrosion cracking (SCC) and hydrogen embrittlement (HE). Localised pitting facilitated passive film rupture, creating preferred paths for SCC crack nucleation and intergranular propagation. These features

The etched micrographs (Figures 4(c)–(d)) provide further insights into crack morphology. The transverse section (Figure 4(c)) displays both intergranular and transgranular cracks, indicative of SCC and HE. This aligns with studies linking environmental (e.g., chlorides/ H₂S) and mechanical (e.g., residual stress) factors to failure progression [1,3,4,10]. The longitudinal section (Figure 4(d)) shows a branched cracking pattern, emphasizing residual stress contributions to corrosion-driven failure. The interplay of pitting corrosion, SCC, and HE underscores the combined role of environmental exposure (moisture, corrosive species) and operational stresses in material degradation.

Figure 4: Optical microscope images of the leaked location. (a) Transverse and (b) longitudinal sections (as-polished) show cracks originating from pitting corrosion and SCC. (c) Transverse and (d) longitudinal sections (etched) reveal intergranular and transgranular cracking

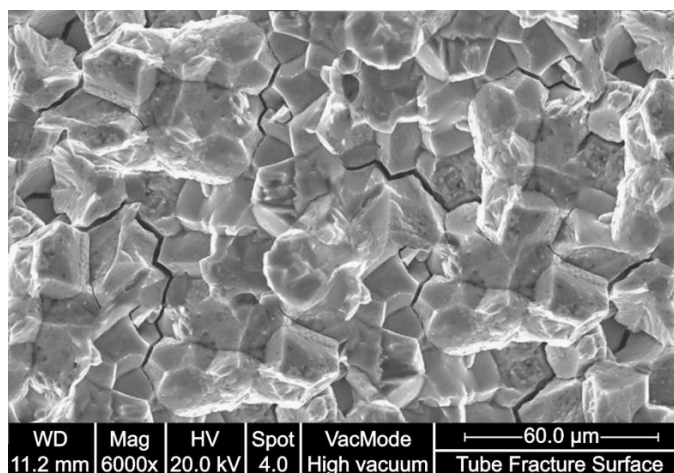
Figure 5 presents scanning electron microscopy (SEM) micrographs of the fracture surface at a pit location, revealing both intergranular and transgranular crack morphologies that provide deeper insight into the failure mechanism. Intergranular cracks follow grain boundaries weakened by hydrogen sulfide (H₂S)-assisted corrosion, a characteristic feature of sulfide stress cracking (SSC) and hydrogen embrittlement (HE) under wet gas environments. The discontinuous and branched nature of these cracks corresponds well with previous studies linking intergranular fracture to hydrogen diffusion and boundary decohesion under corrosive exposure [10]. These findings also corroborate the optical observations in Figure 4(c), which displayed intergranular cracking within the transverse section of the failed tube.

In addition to intergranular features, fine transgranular cracks were observed propagating through the grains, indicating secondary brittle fracture due to cyclic mechanical stresses and thermo-mechanical fatigue during service. This morphology supports the concept of stress corrosion cracking

(SCC) superimposed on hydrogen-related damage, where cracks transition from grain boundaries into the matrix under fluctuating operational loads. Although transgranular cracking was less dominant, its presence highlights the synergistic effect of stress, corrosion, and microstructural weakness in accelerating the overall failure progression of the natural gas fuel tube.

Figure 5: SEM micrographs showing intergranular and transgranular cracking morphologies on the fracture surface of the fuel tube wall

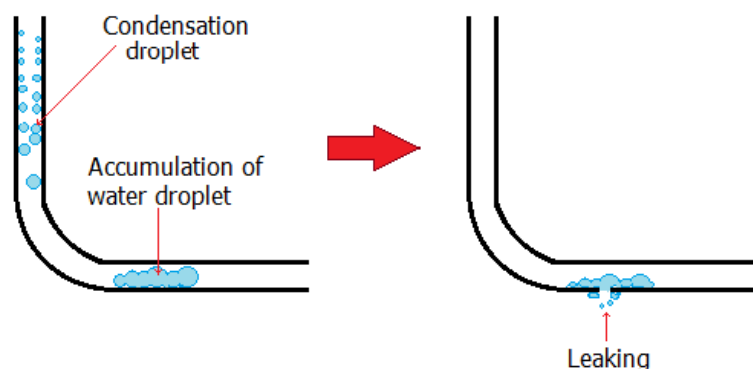
The failure of the fuel supply tubes in the gas turbine system, after approximately 25,000 operational hours, resulted from multiple interacting degradation mechanisms, including condensation-induced corrosion, SCC, SSC, HE, and localised pitting corrosion. Under steady-state operating conditions (20–25 bar, 140 °C), the environment remained relatively dry, minimizing corrosion risks. However, during shutdowns, rapid temperature and pressure drops (to ~1 bar and 25° C) created ideal conditions for condensation. As shown in Figure 6, moisture condensed on internal surfaces, particularly in low-lying regions such as the 6 o'clock position near the bend. The bend geometry exacerbated water pooling, while the coastal environment (250 meters from the seashore) contributed additional moisture via salty air.

Condensation initiated corrosion by destabilising the passive oxide layer. Chloride ions penetrated the oxide layer, creating localised weak points for pitting corrosion. Similarly, H₂S reacted with the oxide layer, forming sulfide compounds that accelerated degradation. Fractographic analysis confirmed intergranular cracking, indicative of SSC, and highlighted the role of HE in accelerating failure. Hydrogen atoms generated from H₂S exposure diffused into the metal lattice under stress, weakening intergranular bonds and reducing ductility. SEM analysis revealed brittle fracture characteristics, supporting findings that HE exacerbates SCC and SSC damage. Chloride ions (up to 5.5 ppm total from HCl, methyl chloride, and ethyl chloride) promoted pitting corrosion by inducing passive film breakdown, creating initiation sites for SCC. Figure 7 schematically illustrates the failure sequence, emphasizing passive film breakdown as the critical first step enabling pitting, followed by SCC/ SSC initiation, crack propagation, and catastrophic failure.

Figure 6: Schematic diagram showing how water droplets from condensation build up and cause the wall tube to leak

To address these issues, rectification measures must focus on design optimisation, material upgrades, environmental controls, and operational adjustments. Redesigning the tube bend with gradual curvature, smooth transitions, and drainage features minimises condensation and stress concentrations, as recommended in pipeline integrity guidelines. Material selection should prioritize alloys with higher pitting resistance, such as AISI 316L (PREN ~25), Lean Duplex stainless steel (UNS S32101, PREN ~26–28), or Inconel 625 (PREN ~50), to mitigate chloride and H₂S susceptibility. PREN (Pitting Resistance Equivalent Number) quantifies resistance to pitting corrosion, with higher values indicating superior performance in chloride-rich environments.

Operational protocols should incorporate gradual shutdown/ startup procedures. For example, reducing pressure to 5 bar over 30 minutes minimises rapid condensation risks. Maintaining residual pressure during shutdowns further reduces moisture accumulation. Proper insulation of the tubing system stabilises internal temperatures, limiting condensation risks. Environmental controls, such as maintaining relative humidity below 50 % using dehumidifiers, are critical in coastal regions. A structured non-destructive testing (NDT) program, including Phased Array Ultrasonic Testing (PAUT) for sub-surface cracks, Eddy Current Testing (ECT) for surface flaws, and Radiographic Testing (RT) for monitoring crack growth, ensures early detection of degradation. Additionally, applying epoxy-phenolic coatings to internal surfaces enhances corrosion resistance and minimises SCC risks. Frequent inspections in high-risk areas, combined with these strategies, will improve long-term structural integrity and operational reliability.
