## MICROSTRUCTURE EVALUATION OF SERVICE AGED AND REJUVENATED NICKEL SUPER ALLOYS USING HOT ISOSTATIC PRESSING TREATMENT

**Abstract.** The design life of gas turbine blades is normally 48,000 equivalent operating hours (EOH) or 72,000 EOH based on the original equipment manufacturer (OEM) recommendation. Extending the service life of gas turbine blades is a huge advantage in the aspect of capital cost-saving in the power plant industries. The coarsening and shape transformation of  $\gamma'$  precipitates are one of the main life-limiting factors for gas turbine blades. Conventional heat treatment could not restore or recover  $\gamma'$ -phase precipitates to their original morphology. In this study, hot isostatic pressing (HIP) treatment was used to improve the material properties of the blades to nearly zero-hour operation and prolong the life of gas turbine blades. HIP rejuvenation applies high temperature and pressure to close the micropores, retransform the microphases (i.e.,  $\gamma'$ -phase precipitates), and heal the material properties. For this case study, three HIP parameters were applied on nickel-based superalloy (GTD-111). Microstructure characterization was carried

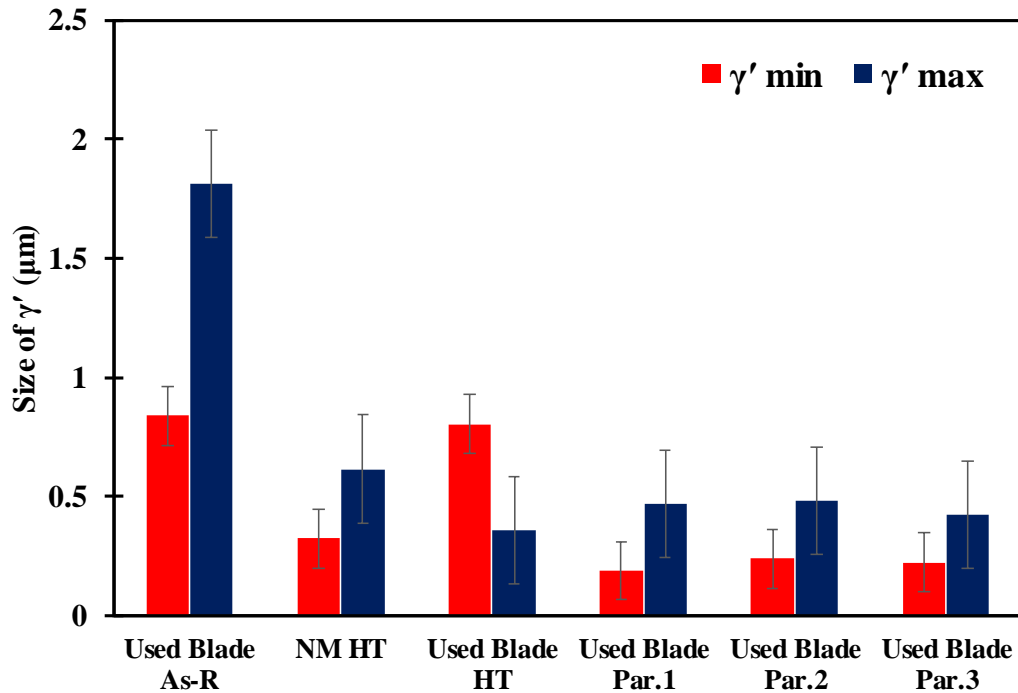
Figure 6. Quantitative measurements of  $\gamma'$  phase size.

Figure 6 shows the results of quantitative measurement of the  $\gamma'$  phase size for the as-received blade (without any heat treatment), the new material after conventional heat treatment, the used blade after heat treatment, and the used blade after HIP (refer to Table 2). The  $\gamma'$  min and  $\gamma'$  max represent the smallest and biggest sizes of  $\gamma'$  phase, respectively. The  $\gamma'$  phase size of the used blade grew and coarsened due to service exposure. It was observed that the heat treatment and HIP treatment affected  $\gamma'$  phase size significantly, as the average  $\gamma'$  phase size of the used blade reduced significantly from 1.297  $\mu\text{m}$  to 0.603  $\mu\text{m}$  after heat treatment. The average size of  $\gamma'$  precipitates in the new sample (the rod after heat treatment) is approximately 0.4  $\mu\text{m}$ . Subsequent to conventional treatment, the HIP treatment reduced the size of  $\gamma'$  precipitates from 0.6  $\mu\text{m}$  to 0.3  $\mu\text{m}$ . It was found that the HIP-treated blades using three temperatures at 1,191  $^{\circ}\text{C}$ , 1,200  $^{\circ}\text{C}$ , and 1,220  $^{\circ}\text{C}$  exhibited an average  $\gamma'$  size of 0.340  $\mu\text{m}$ , 0.327  $\mu\text{m}$ , and 0.324  $\mu\text{m}$ , respectively. Previous studies suggested that the optimal primary  $\gamma'$  phase size is between 0.2 and 0.5  $\mu\text{m}$  [12]. Thus, the experiment data of this study indicate a successful recovery of  $\gamma'$  precipitates to near the original state as all HIPed blades exhibited an average  $\gamma'$  size between 0.2 and 0.5  $\mu\text{m}$ . It was observed that parameter 3 with the temperature of 1,220  $^{\circ}\text{C}$  produced the finest  $\gamma'$  precipitates of 0.32  $\mu\text{m}$ , suggesting 1,220  $^{\circ}\text{C}$  as an optimum temperature to obtain the optimal primary  $\gamma'$  phase size. It is important to obtain the optimal primary  $\gamma'$  phase size in order to strengthen and enhance the creep property of the materials.

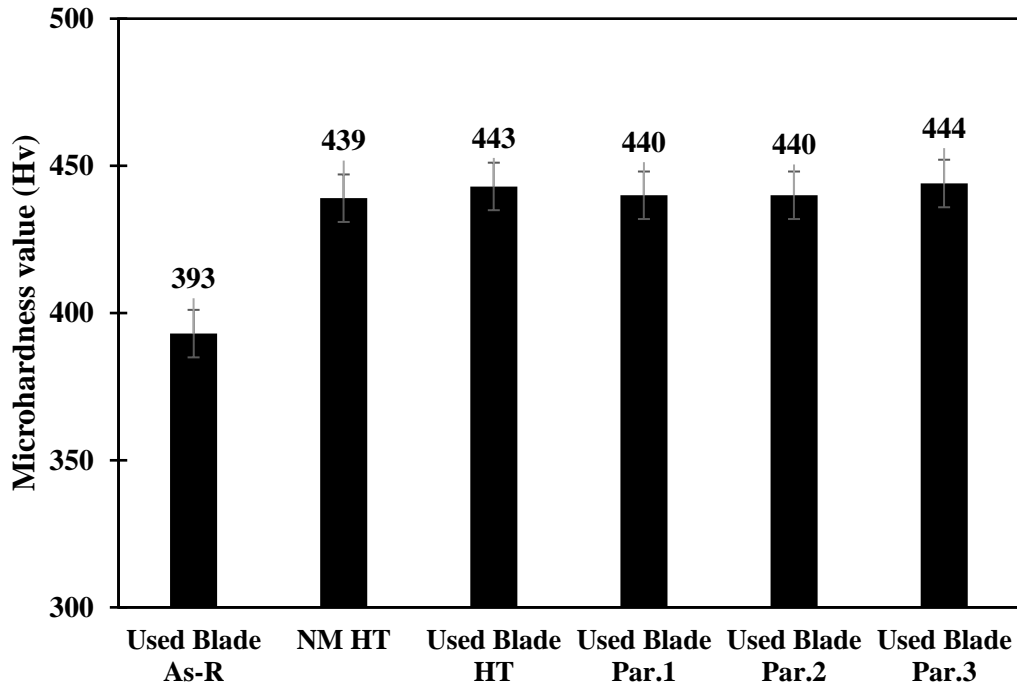
**Figure 7. Hardness Value**

**Microhardness testing.** Figure 7 presents the effect of rejuvenation conditions on microhardness changes in the samples. It was observed that HIP rejuvenation increased the hardness property of the used gas turbine blade for all parameters. The hardness property of all HIPed blade samples appeared to have a consistent value at ca. 440 HV and did not deviate significantly from new materials, which has a value of 439 HV. This may occur due to its fine and uniform distribution of  $\gamma'$  precipitates in the  $\gamma$  matrix, as shown in Figure 4. On the other hand, the microstructure of the as-received used blade exhibited a coarse and degraded  $\gamma'$  phase, thus lowering its hardness value. The microhardness results suggested that the variation in hardness value is likely related to the type, shape, size, and morphology of microphases, as all samples besides the as-received used blade exhibited similar uniform and defined shape of  $\gamma'$  phase (Figure 4) [13]. Thus, it is suggested that HIP treatment has successfully increased the hardness property of the used gas turbine blade near its zero-hour condition.
